REPAIR INSTRUCTION NO. RI-1078-94/1

G 115E / EG all as affected

Repair of hinge bracket attachment points – AILERON

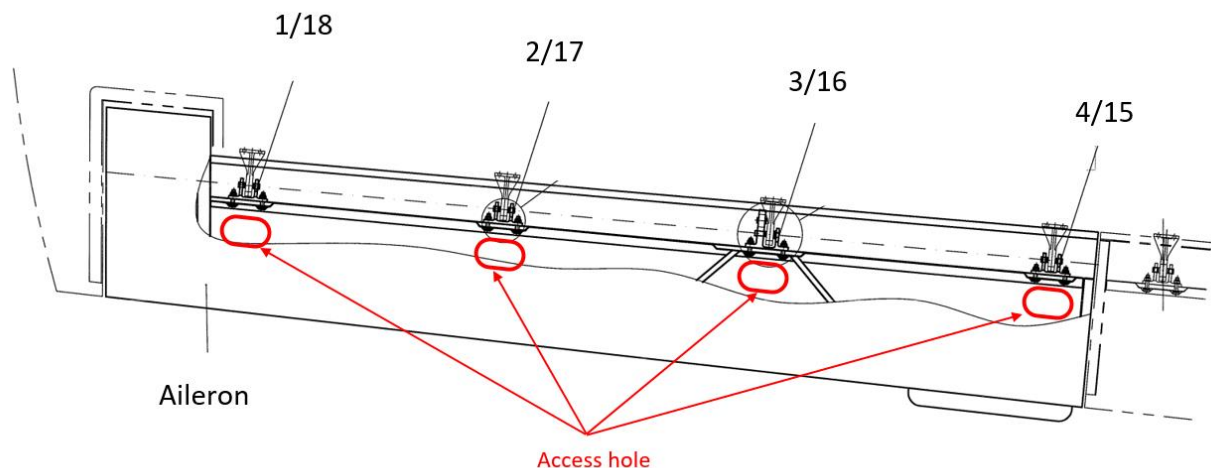
Figure 1: Aileron Access Holes and Hinge Bracket Locations (LH shown, RH mirrored)

CAUTION: At location 3/16 a 6mm thick repair plate (instead of a 4mm) is installed with a longer bolt.

- 7.1.1 Make the aircraft safe for parking, refer to AMM Chapter 10-10.
- 7.1.2 Remove the aileron, refer to AMM Chapter 57-60.
- 7.1.3 Remove the affected hinge bracket from the aileron. Discard the lock nuts.
- 7.1.4 Cut an access hole into the aileron surface as small as practical, refer to Figure 1.

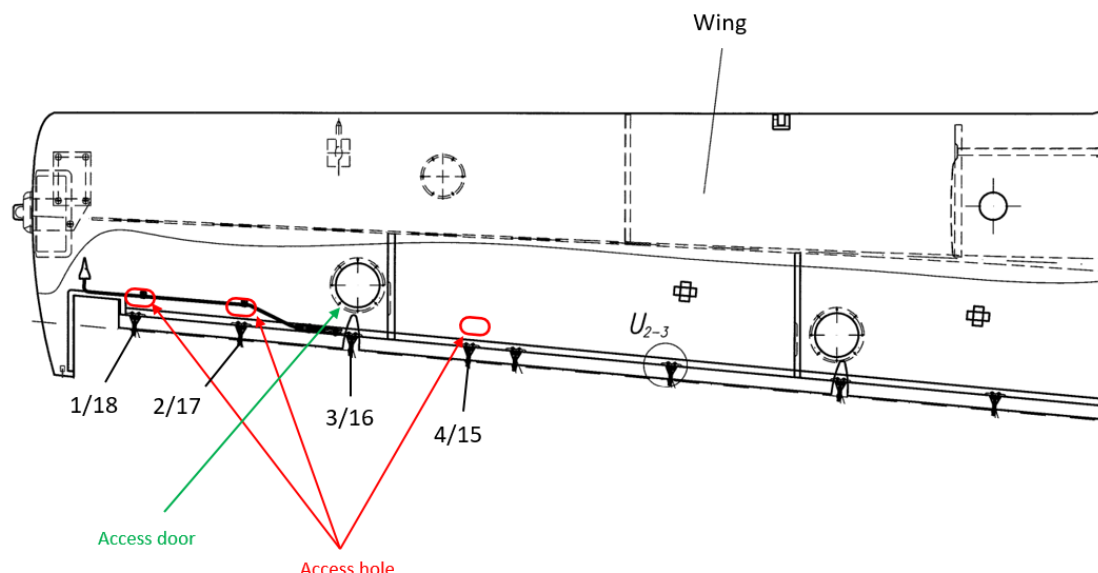
Figure 8: Wing Access Holes and Hinge Bracket Locations (LH shown, RH mirrored)

Note: A lightning protection sheet is installed at location 1/18. If you repair location 1/18 the lightning protection sheet remains installed and the repair plate is installed to the side without lightning protection. Only the bolts are removed from the lightning protection strip and replaced with bolts (item 1 of List 9) and washers (item 6 of List 9). If a damaged lightning protection sheet has caused an additional damage to the plywood sandwich below, please contact Grob.

- 7.2.1 If required, make the aircraft safe for parking, refer to AMM Chapter 10-10.
- 7.2.2 If required, remove the aileron, refer to AMM Chapter 57-60.
- 7.2.3 Remove the affected hinge bracket from the wing. Discard the lock nuts.
- 7.2.4 If required, cut an access hole into the wing surface as small as practical, refer to Figure 8.
